# Mount Vernon

### **Laundry Color Wash Study: Phase II – Distribution System**

April 14, 2009

Prepared by:  
ARCADIS  
520 South Main Street  
Suite 2400  
Akron  
Ohio 44311-1010  
Tel 330.434.1995  
Fax 330.374.1095

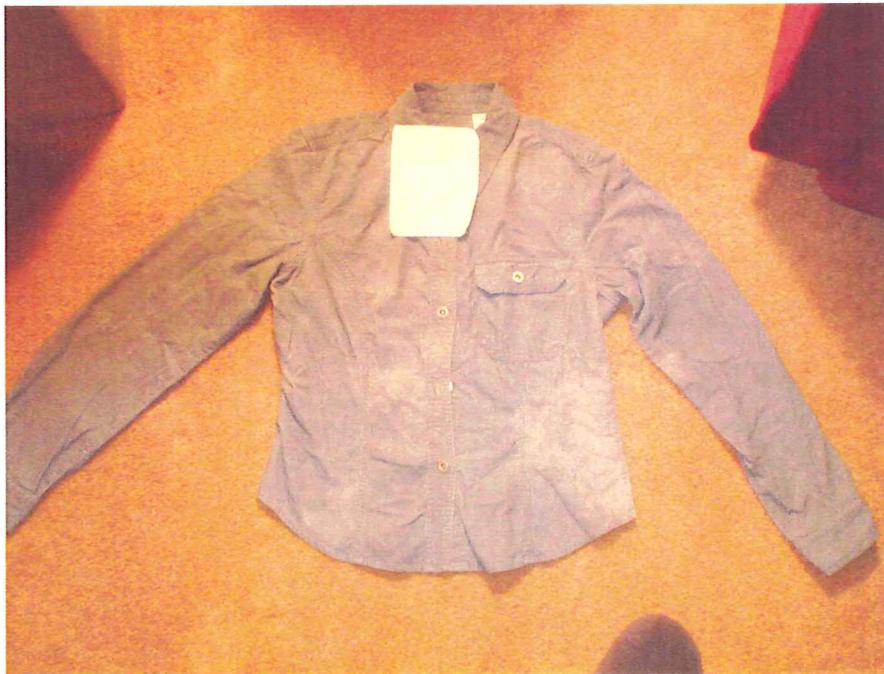
**Figure 1 – Faded areas on garment typical of the "spotching" effect**

In review and evaluation of the piping materials, there is no evidence to suggest old pipe materials are corroding due to unstable water which could possibly lead to release of mineral deposits from piping. The release of these materials was a theory of what may cause the splotching problems, but this has been ruled out. In addition, mineral releases that stain generally show up as distinct spots and not as bleached or faded areas as shown in the clothing samples illustrated in Figure 1 and Figure 2.

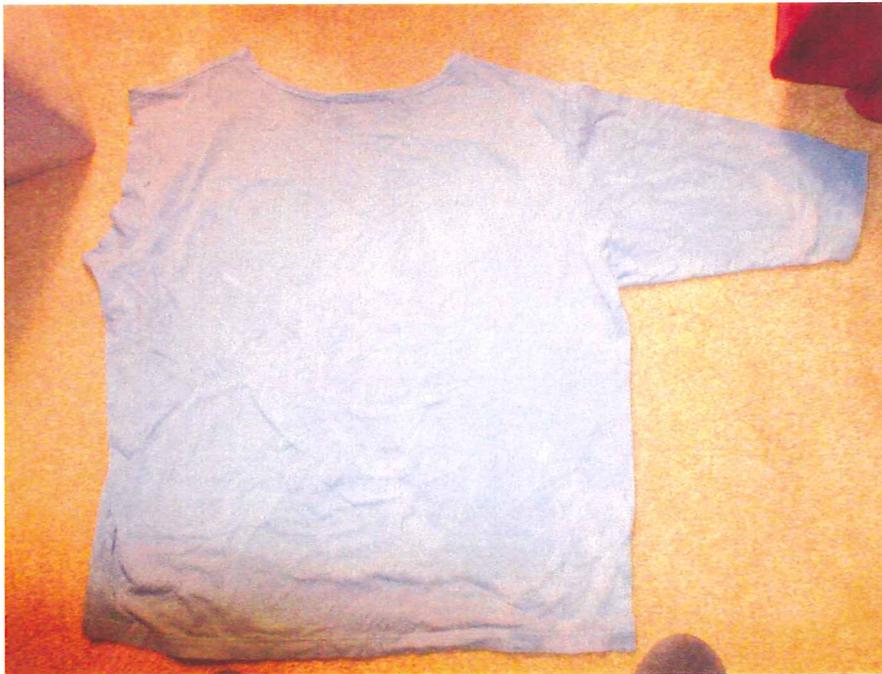
**Figure 2 – Shirt displays multiple areas of the "splotching"**

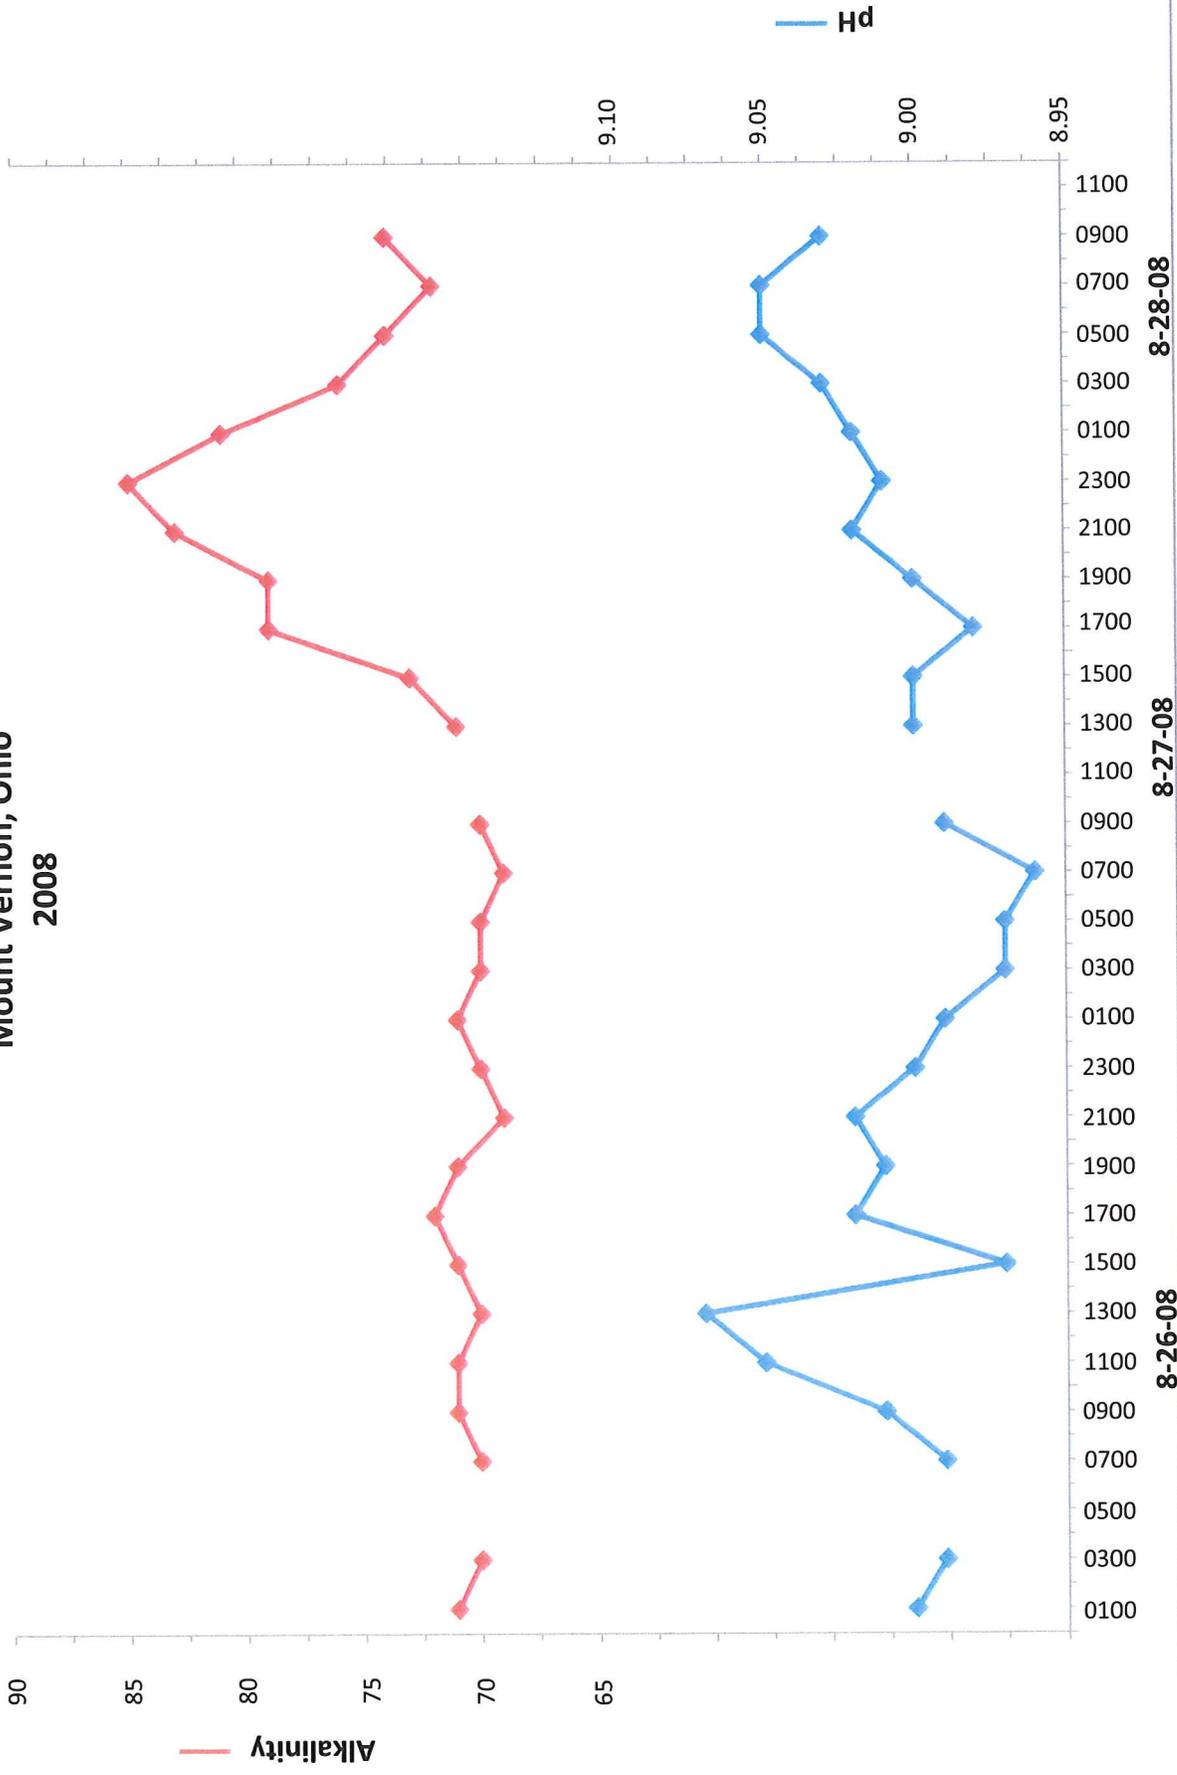
Plant Tap  
 Alkalinity / pH Data  
 Mount Vernon, Ohio  
 2008

The Plant Tap data was initially evaluated for the two and one-half days provided by the City. A graph was developed for the pH data and is included in Appendix B. The pH data shows a very consistent level of approximately 9.0 SU with little variation

throughout the course of a day as well as between days. The pH value of 9.0 SU is reasonable and the consistency of pH is an indication that the City is very efficient in managing chemical usage to accomplish target softening goals without wasting lime. It would also suggest that some scale is forming in the system but not to a significant degree. This is a desirable condition.

The Plant Tap data for alkalinity was evaluated for the same period. A graph was also developed for the alkalinity data and is included in Appendix B. Alkalinity consistently ran at approximately 70 mg/l CaCO on August 26<sup>th</sup> and through the morning of August 27<sup>th</sup>. The afternoon and evening on August 27<sup>th</sup> showed a noticeable rise in alkalinity from approximately 70 mg/l CaCO to 85 mg/l CaCO. Over the course of the morning on the following day, August 28<sup>th</sup>, the alkalinity began to lower. It appears that the water leaving the plant is stable and therefore a slight coating of the distribution system should be occurring.

Regarding the increase in alkalinity noted in the previous paragraph, the pH remained unchanged during this increase in alkalinity on the afternoon of August 27<sup>th</sup>. Checking with plant personnel, it was discovered that a load of lime disrupted operations at the plant that day. During that time the system is shut down, which apparently caused a spike in alkalinity with no recarbonation occurring.

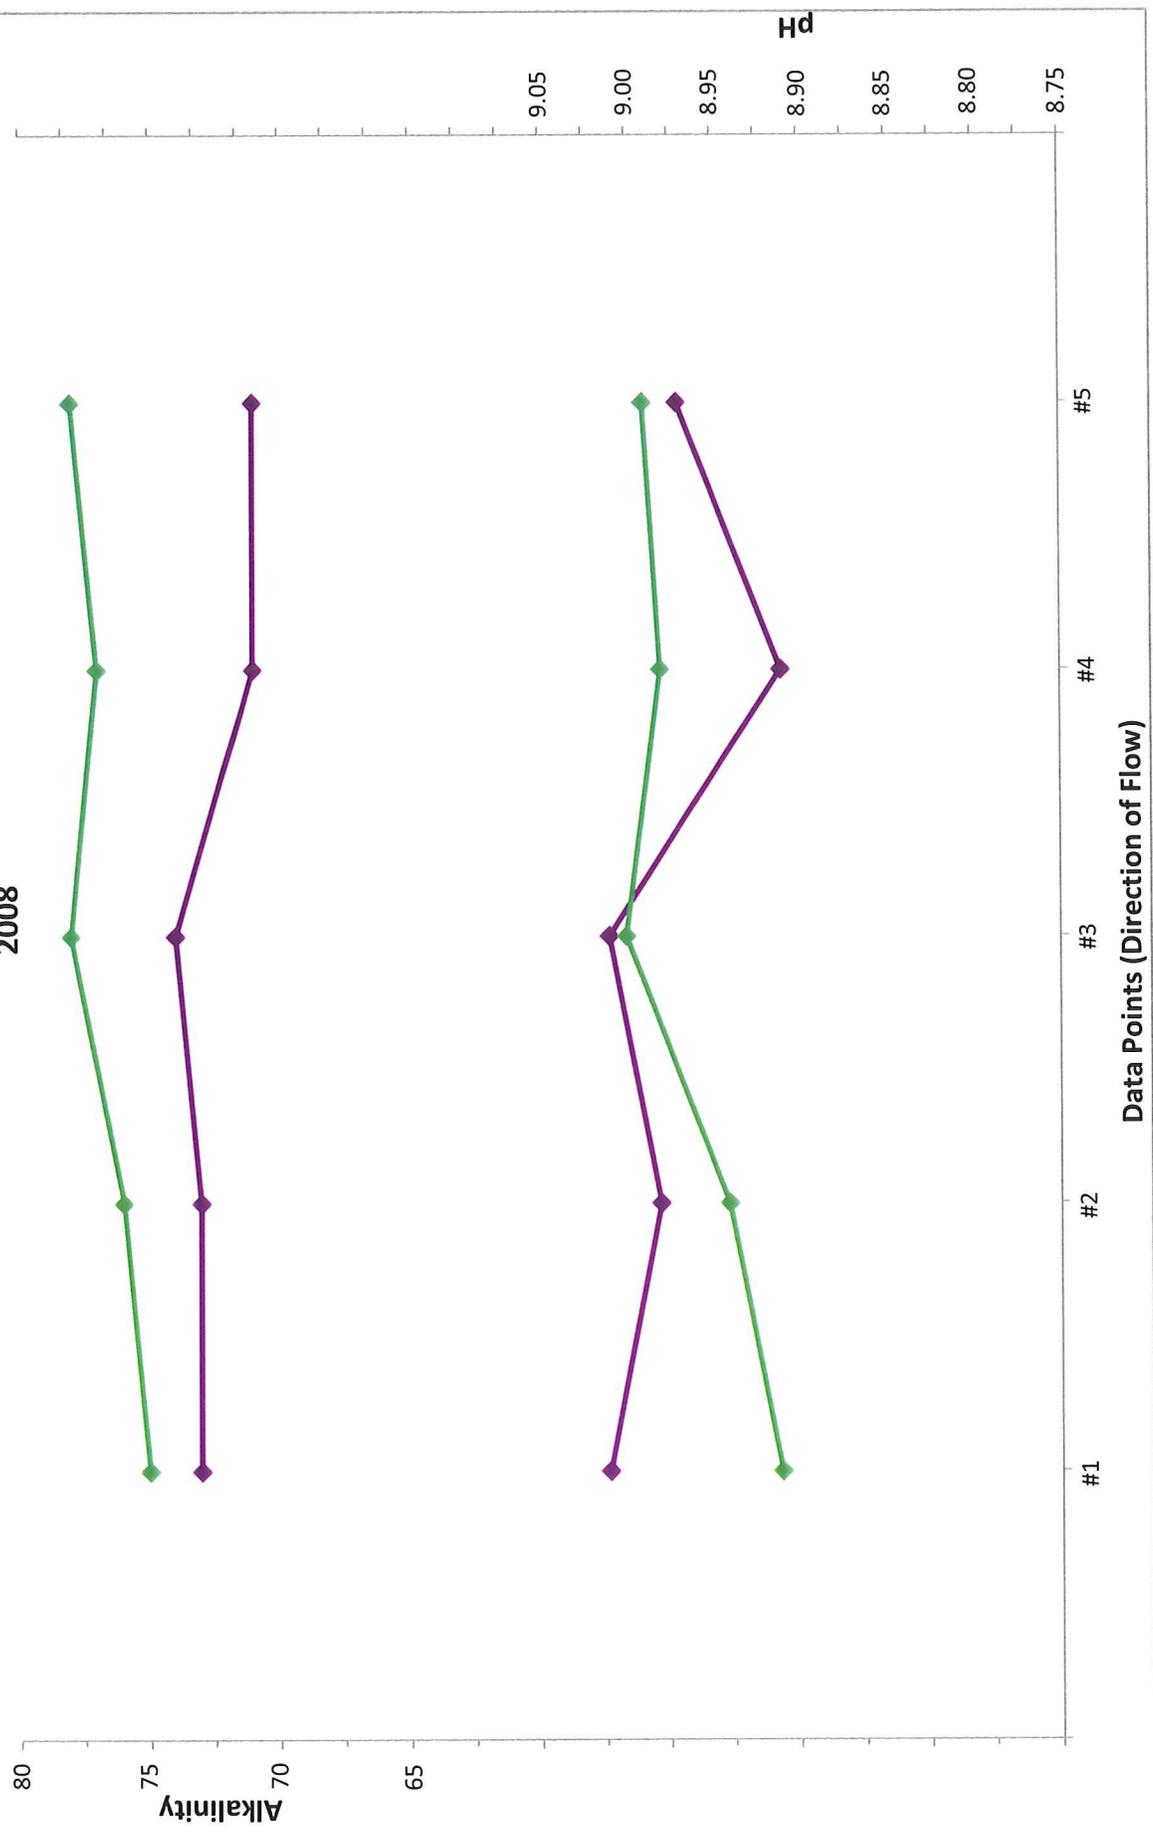
# Alkalinity / pH Profiles Mount Vernon, Ohio 2008

For the Rogers/Braddock area, the pH maintains at 9.0 SU with a slight drop between the 3<sup>rd</sup> and 4<sup>th</sup> data points. This drop corresponds to a drop in alkalinity which ranged from approximately 70-75 mg/l CaCO. However, there is no consistent pattern to suggest a gradual reduction in alkalinity as water moves through the system in this area. Also, the sampled points do not represent water moving through the system as they are from different connection points along the Pleasant Street and Coshocton Avenue water mains.

For the Chestnut area, the pH and alkalinity show a gradual increase over the initial three data points as water moves through the system from west to east, with a subsequent leveling. The alkalinity in this area ranged from 75-78 mg/l CaCO which is higher than that recorded in the Rogers/Braddock area.

For the minor variations in pH and alkalinity values measured in the system, a general observation may be made that the distribution reflects the plant consistency of water quality without any distinct departures in the parameters. This would imply a relatively stable system and there is no evidence to conclude that the distribution system experiences any water quality conditions that would lead to splotching.
