Kokosing River Restoration Project FAQs

This question and answer document is centered around the Engineering, Science, and Habitat Conservation Techniques that are being used to complete our Kokosing River Restoration.

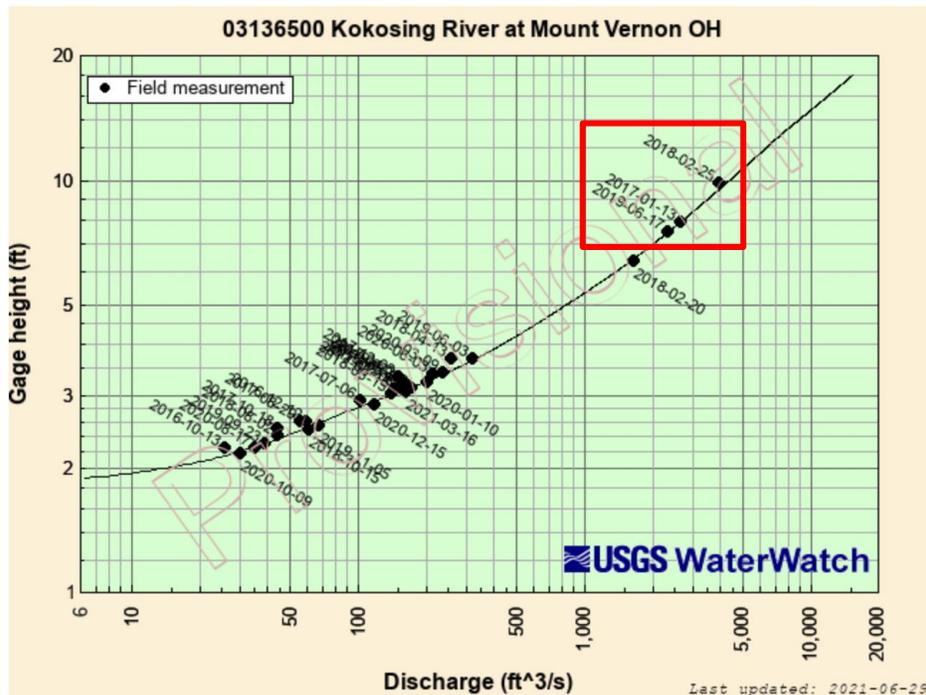
Flood events in 2017 and 2018 left the river bank severely eroded, resulting in a direct connection between the West Lake at Foundation Park and the Kokosing River. The goal for the West Lake project is to remedy the breach in the streambank between the lake and the river. You can see just how severe these flood events were by looking at data in the red box on the graph below which shows how much water discharge occurred during the events measured by the gage height (a gage is a tool used to measure river height. It is used to show large fluctuations in river depth, this U.S. Geological Survey graph uses a 2 foot height as a reference point which they then use to measure the water height above). The flood events that caused the most damage were a 2017 flood event that had a height of 8 ft and another event in 2018 with a height of 10 ft.

Large stone was placed to close the breach in the between the river and the lake. The material that now fills the breach is sturdy and has allowed for a wider, and taller structure to be made between these bodies of water. These changes made in this project will ensure stability for the raised bank in future flood events, Berm is the technical term for this structure.

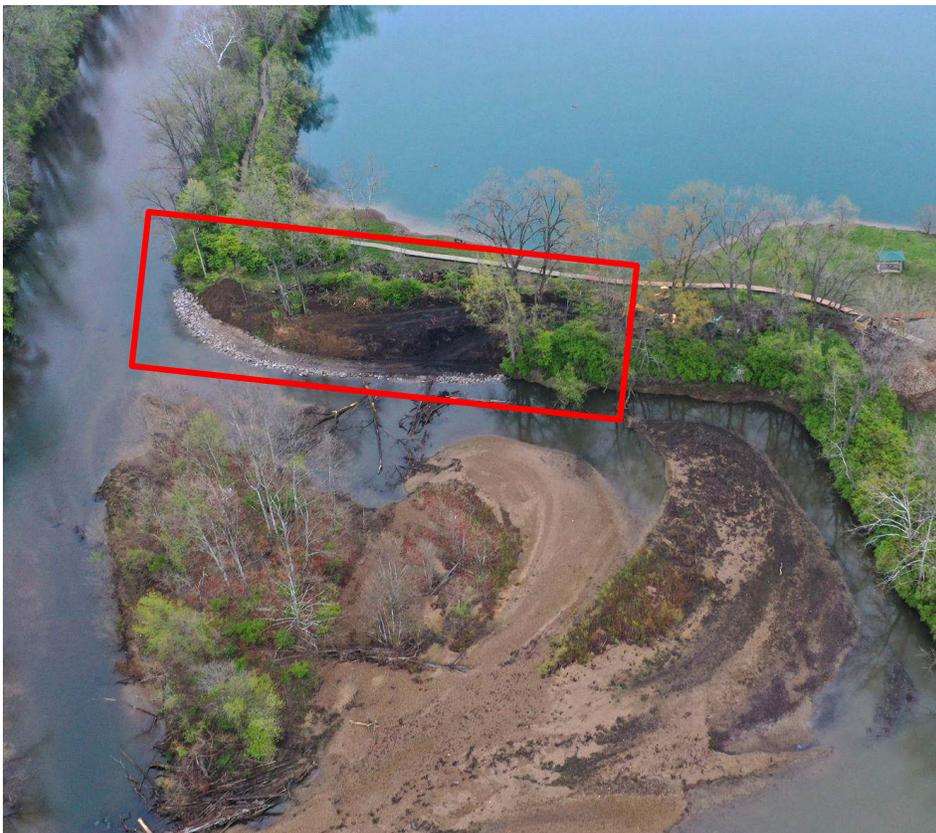
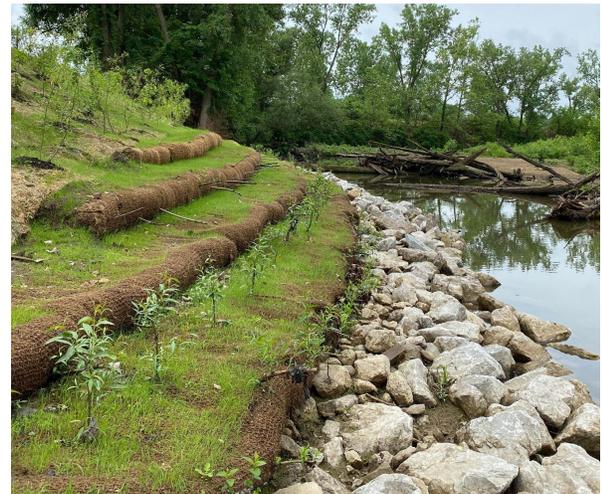
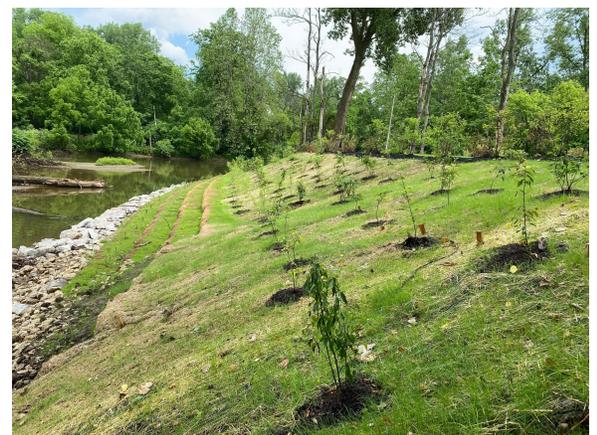
The goal for the Norton Street project was to restore approximately 700 linear feet of the embankment along a backwater channel section of the Kokosing River. The backwater channel of the river is located near Foundation Park's East Lake. It is a branch of the main river that curves around some small island features and has little or no current till it meets back up with the main river channel. By restoring the embankment between this channel and the East Lake it will protect the river from breaching into the lake in future flood events, like it has done in the past, and will also protect the riparian corridor (riparian corridor meaning the vegetation, habitat, and community situated on the bank of the river).

The restoration of the embankment consisted of using limestone rock to construct a stable foundation to stabilize the riparian corridor. Above the average high water line where the limestone rock foundation stops there are four soil lifts that were constructed that are encased in a product called "D" block, this is a burlap and jute matting material that holds the soil in place and allows for woody and herbaceous plants to grow as the matting slowly degrades. The rest of the projects focus was to plant vegetation of appropriate native plants for the area along the riparian corridor and down to the East Lake.

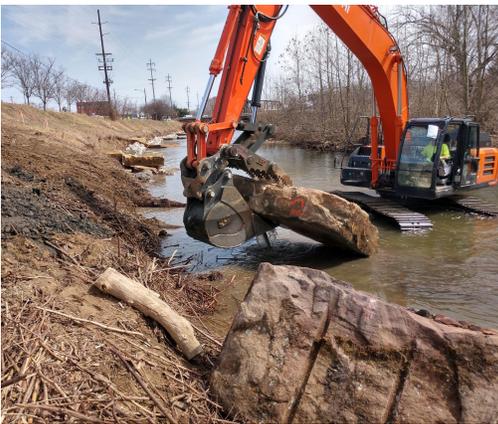
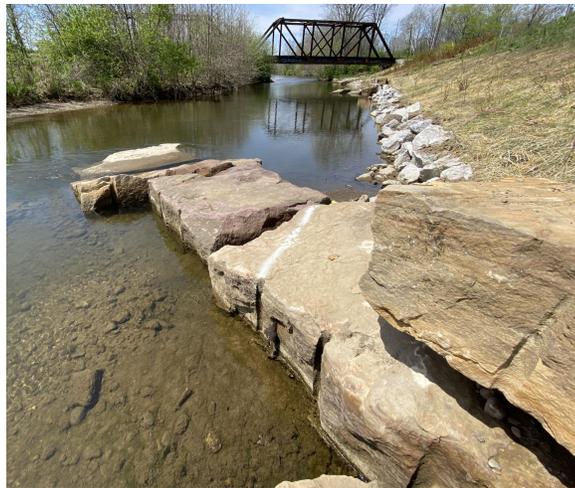
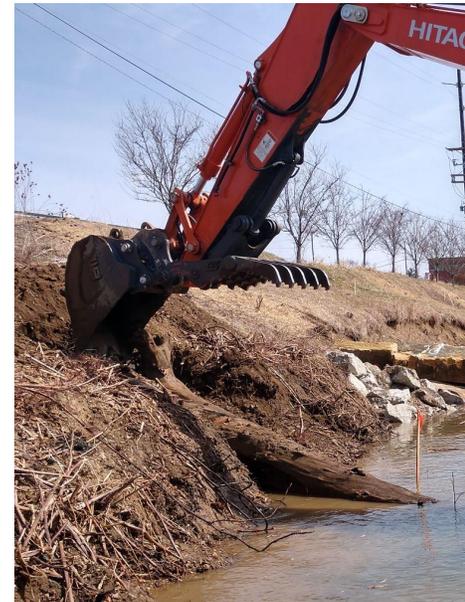
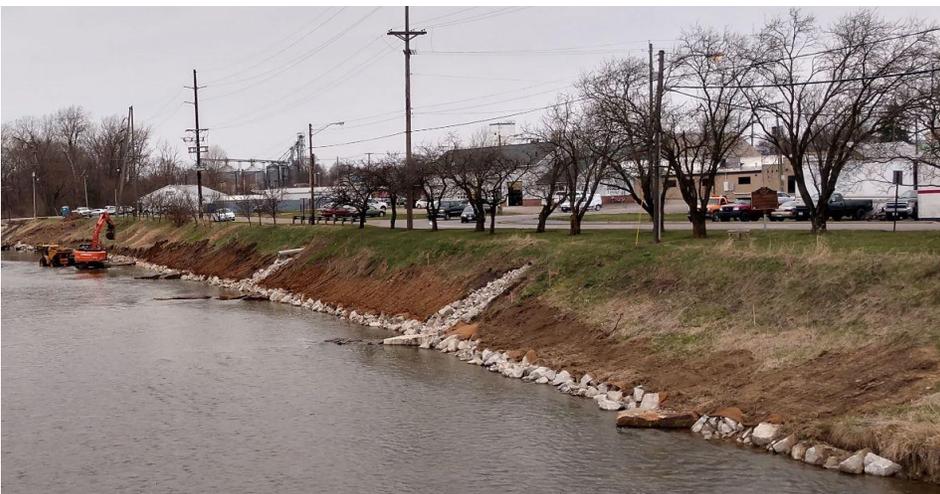
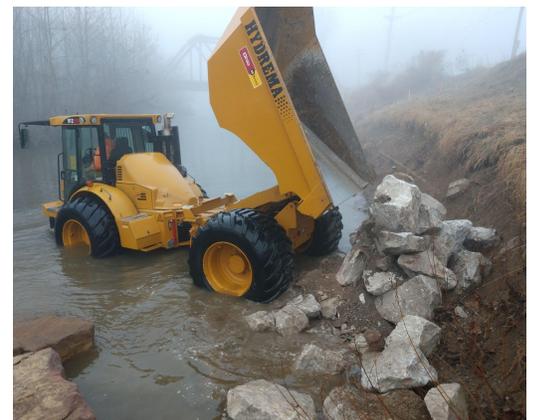
The goal for the Phillips drive project is to restore approximately 800 linear feet of failing and unstable river bank. In order to fulfill that conservation goal different types of rock, gravel, and boulders were embedded along the river bank to provide it with additional stabilization along with the replanting of 21 different types of vegetation on the bank. This work will ensure that the soil below the rocks and vegetation will not get washed away and continue to be eroded during flood events.

The largest rocks used along the river bed were sandstone slabs. These ranged from 2.7 to 7.9 tons each. The slabs were maneuvered into the river and stacked at an angle from the river bank into the river about 12 feet. These are called Cross Vanes. The use of Cross Vanes are considered a deflection technique. They deflect water flows away from the river bank creating turbulence which dissipates energy and lowers the stress that is applied near the bank. This deflection and dissipation of energy not only prevents erosion but also improves the establishment of protective vegetation along bare river banks.
