# Kokosing River: Armstrong Run

HUC-12 (05040003 03 02)

## Nonpoint Source Implementation Strategic Plan

March, 2018

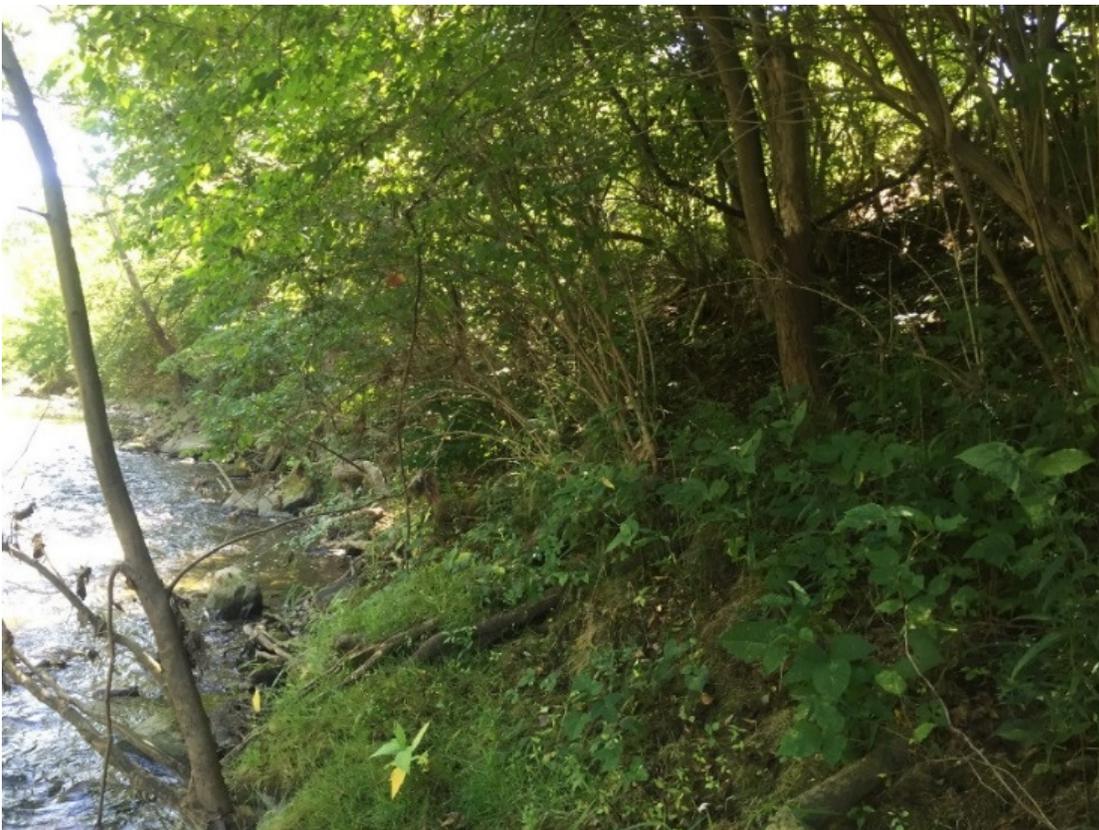
*Figure 7:* Levee separating the Kokosing River from Quarry 1, at upstream end near RM 27.3, with adequate vegetation and stable banks.

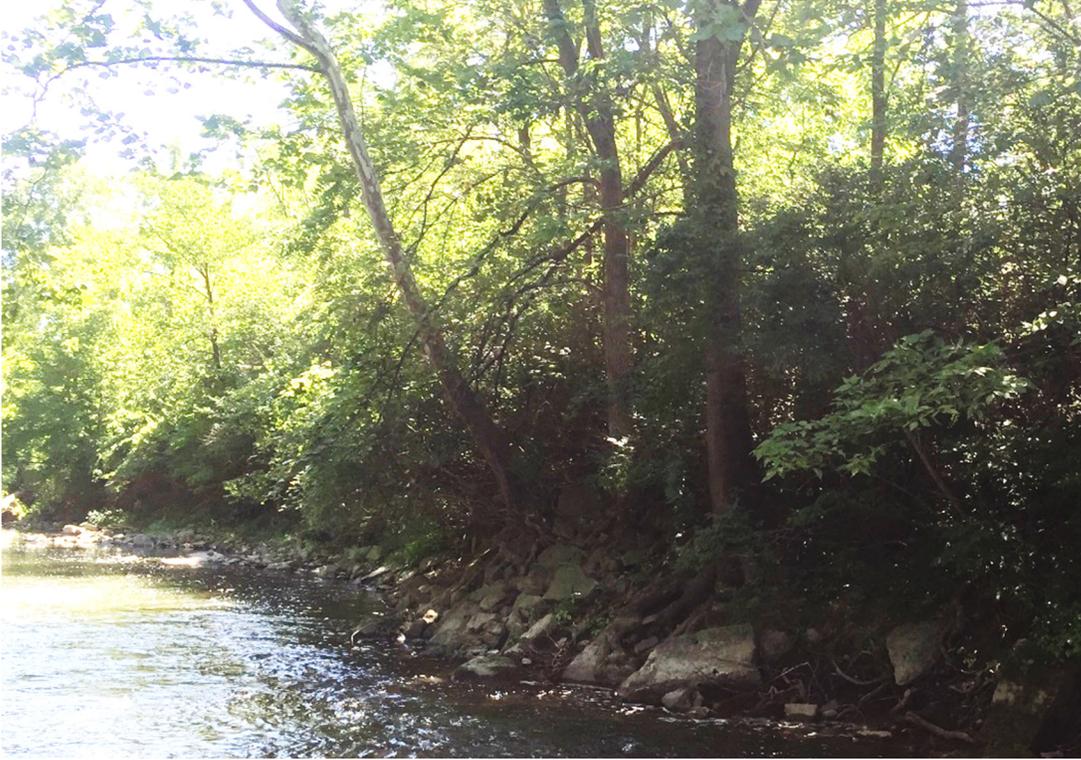
*Figure 8:* Armoring of levee at Quarry 1 near RM 27.3.

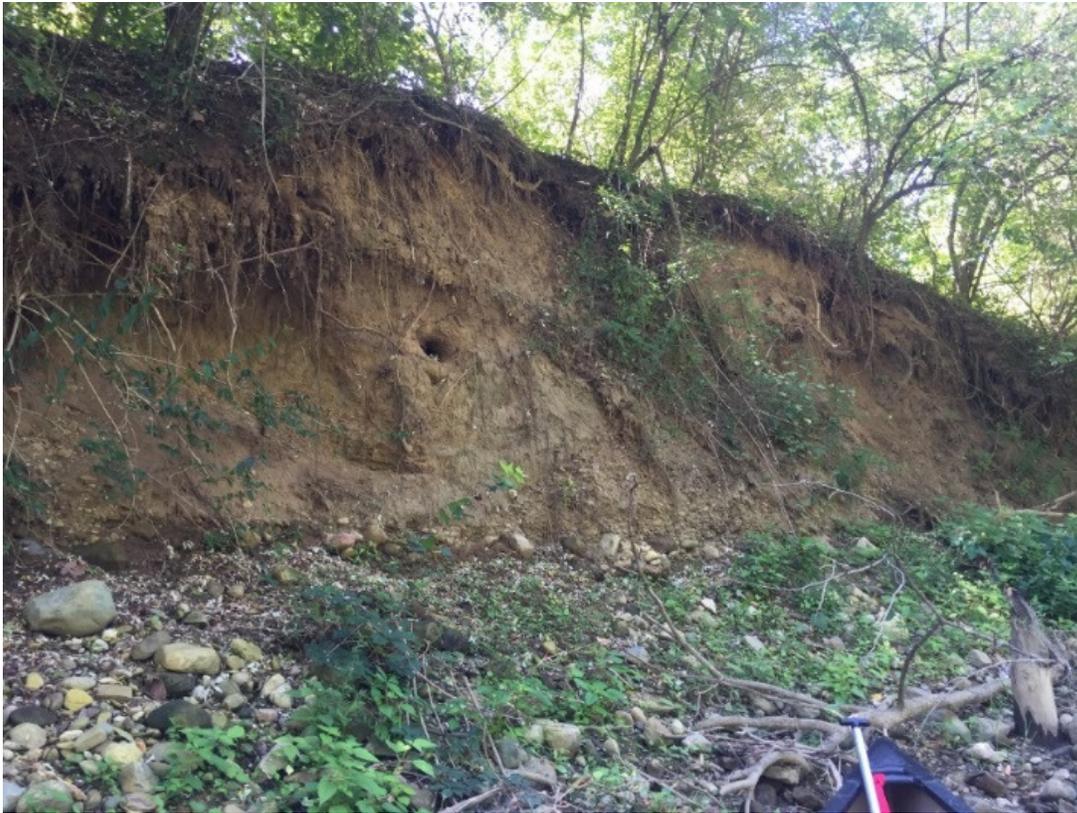
*Figure 9:* Levee bank erosion at Quarry 1.

This reach is adjacent to the Quarry 1. The right descending bank (looking downstream) features a narrow, wooded levee that separates the river from the lake with some areas of severe erosion. Bank erosion is of particular concern here because worsening conditions could lead to a breach of an especially narrow section (at RM 27.25) that is 35 feet wide. A levee breach did occur just downstream from this location at RM 27.1, at a section that was slightly wider but lower in elevation.

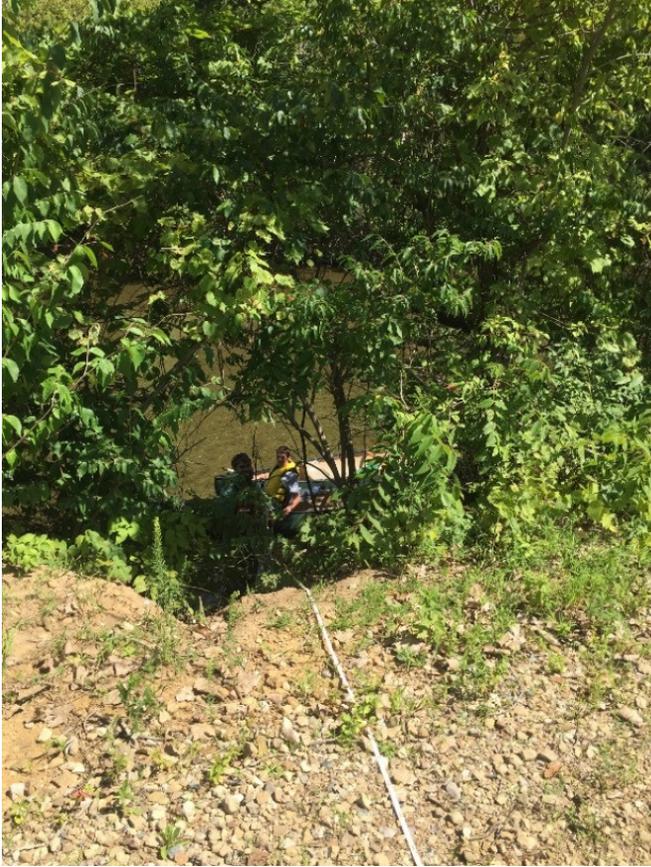
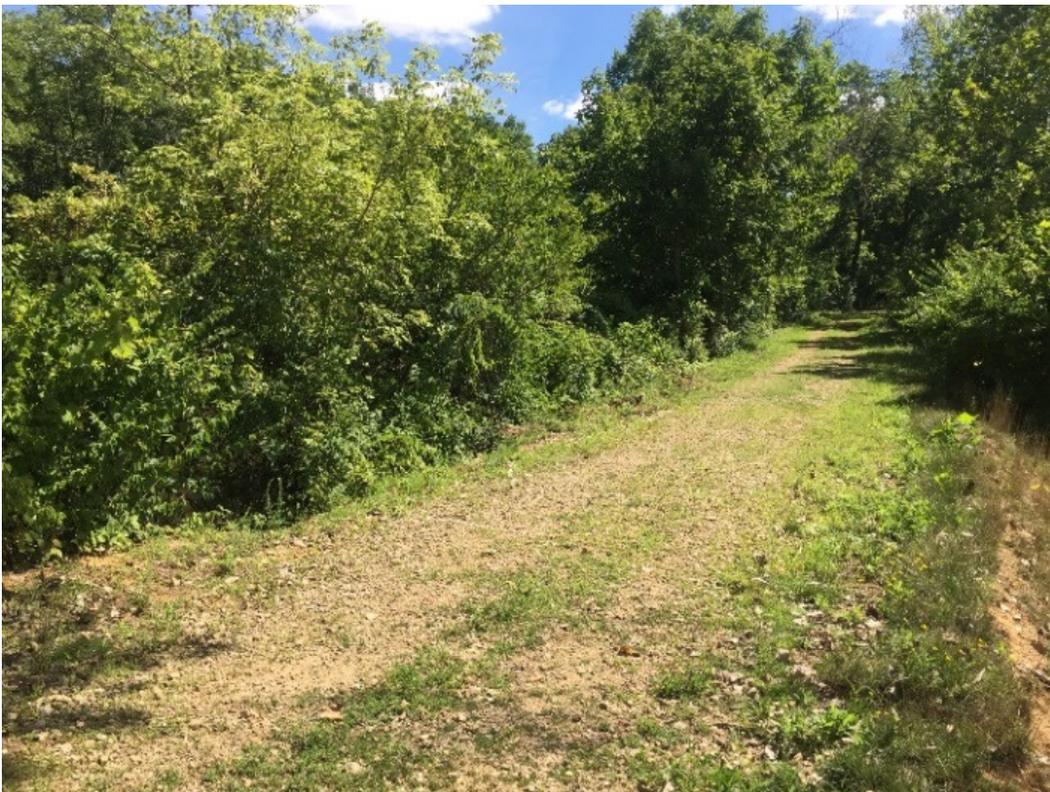
*Figures 10 (left) and 11 (below):* A narrow section of levee separating the Kokosing River from Quarry 1 at approximately RM 27.3 measures 10 feet tall and 35 feet wide.

A particularly steep, narrow section occurs downstream at approximately RM 27.25. The city found this point to be quite unstable and reinforced it with new material on the lake side of the levee approximately 10 years ago. Figures 10 and 11 illustrate that the levee here is steep, relatively short, at about 10 feet tall, and very narrow, at just 35 feet wide.

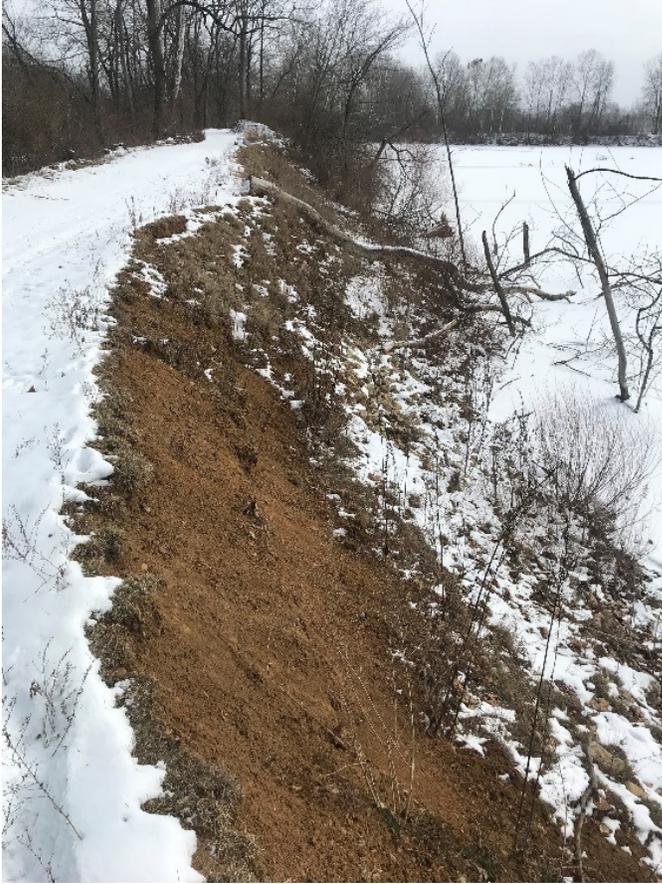
*Figure 12:* Flood water moving through narrow quarry levee at RM 27.3 caused material to slump on quarry side.

A subsequent 10-year flood event in December, 2017 nearly topped this portion of the levee. Although the levee held, water seeping through it caused material to slump and sheer-off on the quarry side (Figure 12), further weakening the structure.

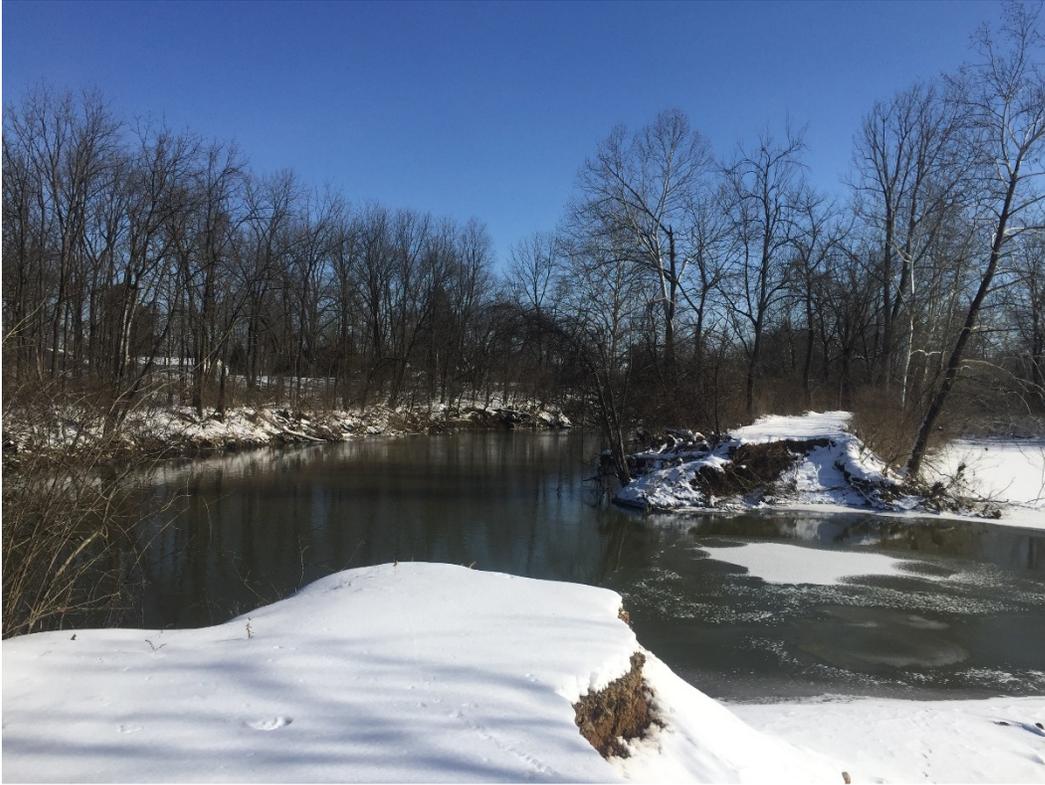
*Figure 13:* Levee breach at Quarry 1, RM 27.1, looking east / downstream. The river is located on the left and Quarry 1 on the right.

The same December, 2017 flood event resulted in a levee breach just downstream at Quarry 1, RM 27.1. The levee is slightly wider here than at RM 27.25, but also slightly lower. Flood water poured over the levee into the lake, which was at a much lower elevation than the river, and eroded the back side of the levee. The overflow eventually eroded through the entire width of the levee until it reached the river. The resulting gap, where the river now flows freely into the quarry, is approximately 100 feet long (Figure 13 and Figure 14).

While the levee system presents challenges to river habitat and ecological processes, the uncontrolled breach that occurred here presents a different set of challenges. Should the breach widen to the extent that the river flows into and is completely captured by the lake, the result would be a complete loss of stream habitat in that reach. A slightly less damaging outcome would be higher flow into the lake from the breach could reduce energy and channel forming flows downstream that inhibits habitat development. Additionally, a large volume of soil was washed into the river and lake when the breach occurred, and additional soil loading will occur as the breach widens.

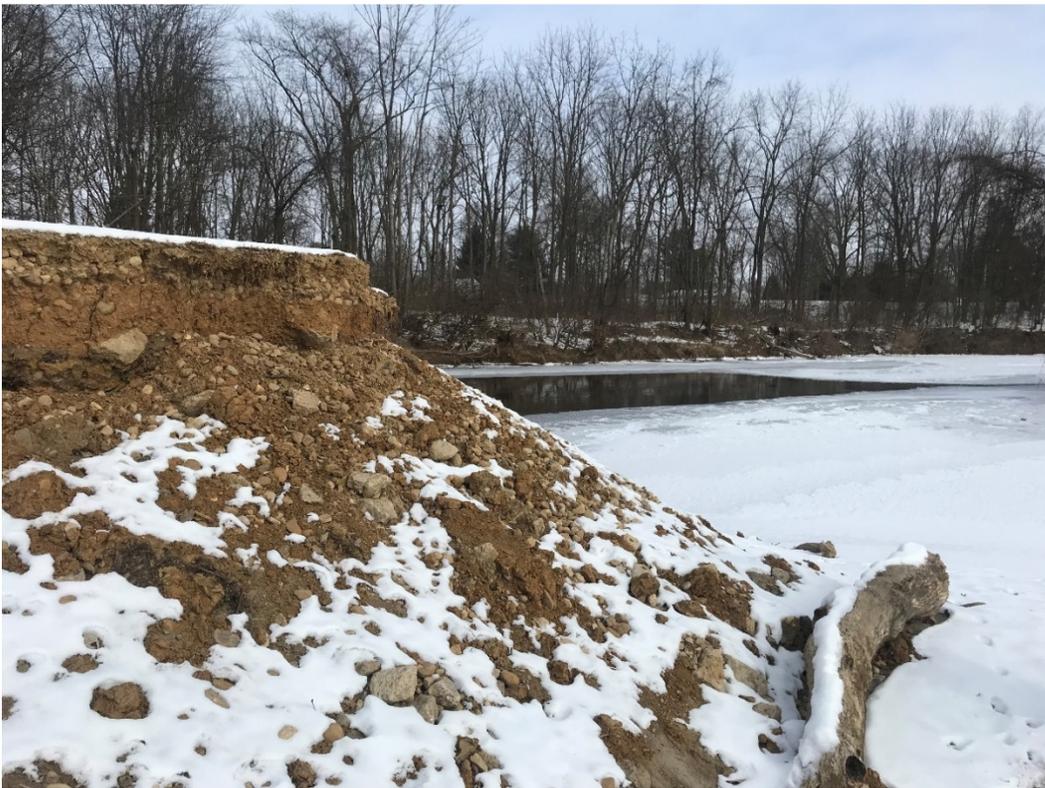
*Figure 14:* Side view of levee breach at Quarry 1, RM 27.1, on quarry side looking towards the river.

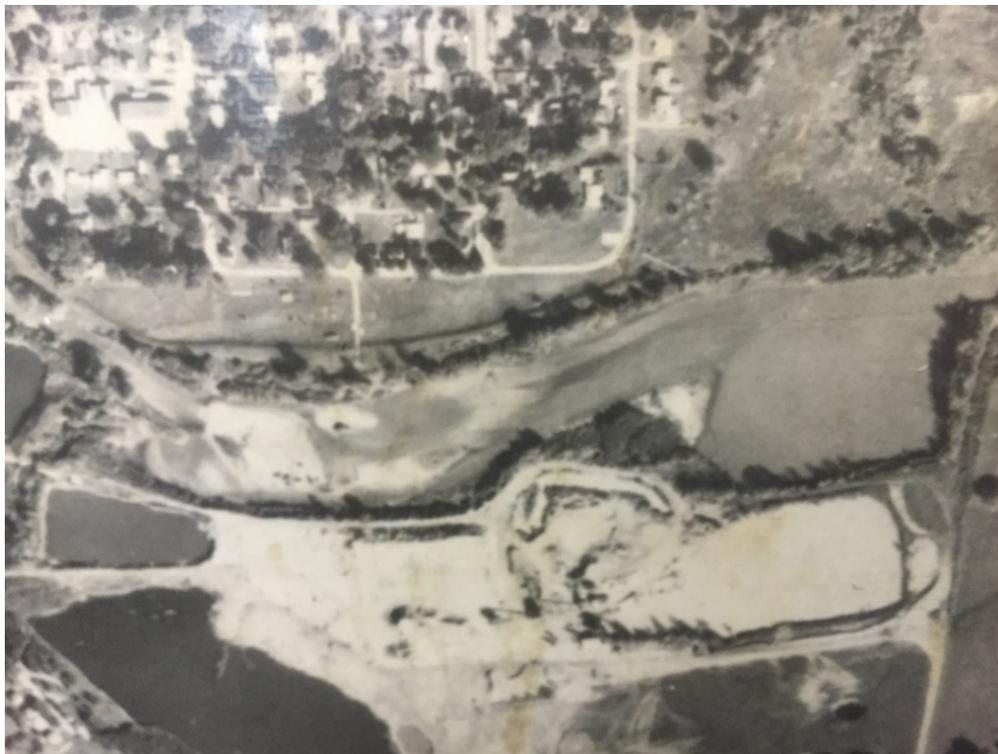
Figure 16: Aerial photography (circa 1968) shows extensive stream bank mining further east and west than shown in 1961 topographic map above. (Image courtesy of City of Mount Vernon Engineering Department)

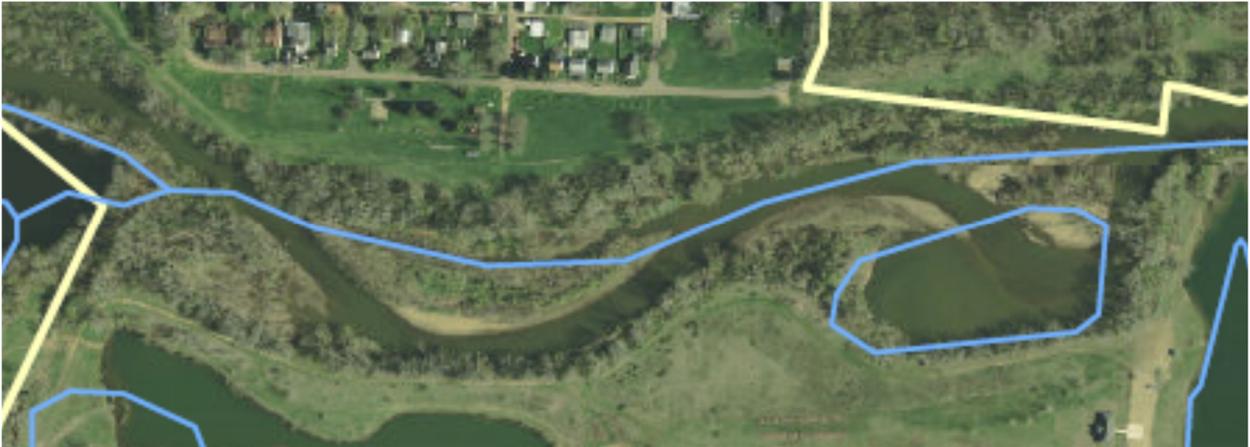
*Figure 17:* Aerial photography taken between 2010 and 2015 shows braided river channels upstream of the Norton Street corridor and remnant in-stream mining backwater. The dominant channel with the majority of volume flows into the backwater and south around an island.

Aerial photography shown in Figure 17 from between 2010 and 2015 shows the dominant channel flowing southeast into the backwater and around an island. More recent aerial photography in Figure 18 shows that flow has shifted. More flow can be seen in the northernmost channel bypassing the backwater as well as additional sediment deposition in the backwater directly south of the island. A site visit in August, 2016 confirmed even less flow into the backwater and a new, northern opening to one of the braided channels north of the island (Figure 19). This migration represents positive channel recovery and reduced flow through the very low-quality habitat backwater (Figure 20).

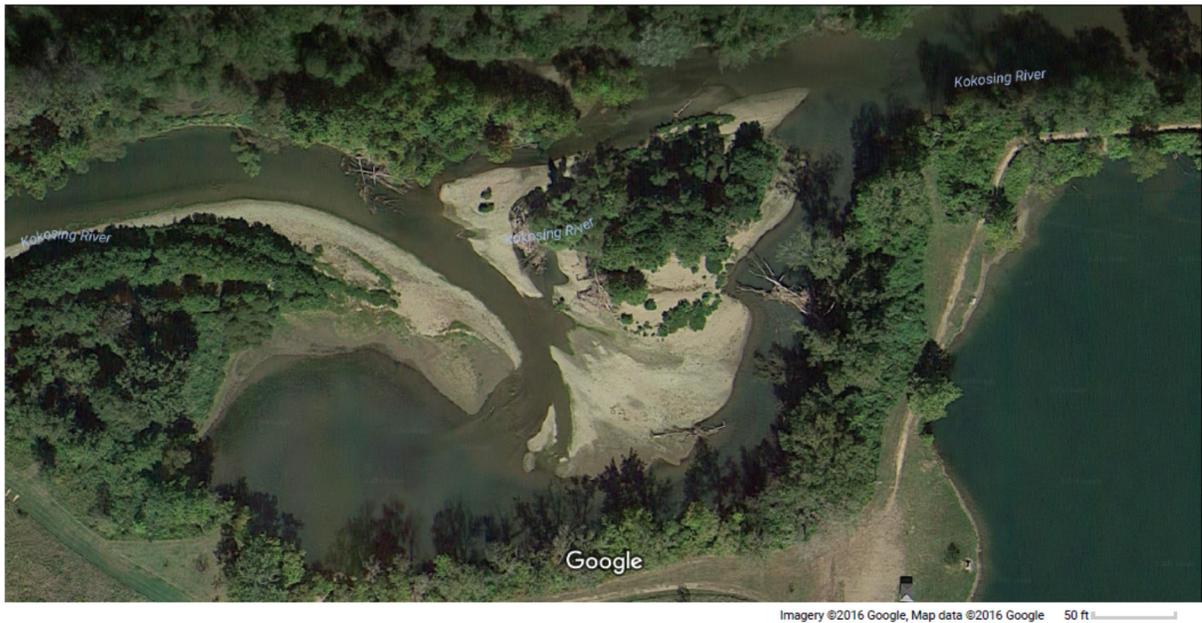
*Figure 18:* Aerial photography generated from Google maps in 2016 shows the increasing size of the northern channel and increasing sediment deposition south of the island.

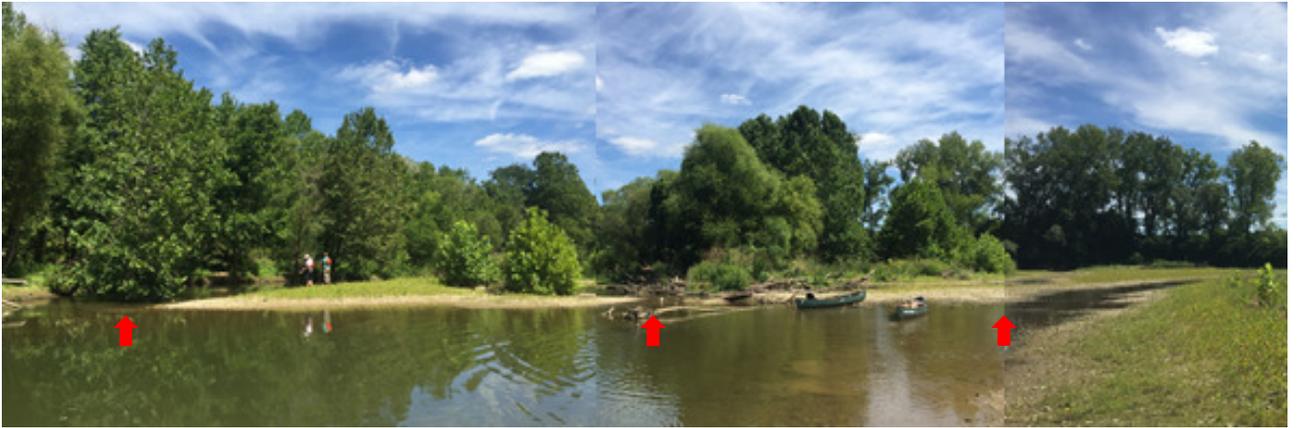
*Figure 19:* The braided channel in August, 2016, looking downstream at the head of the island. Arrows, from left to right, show widening northern channel, new opening for a secondary channel north of the main island, and diminishing third channel flowing towards the open backwater south of the island.

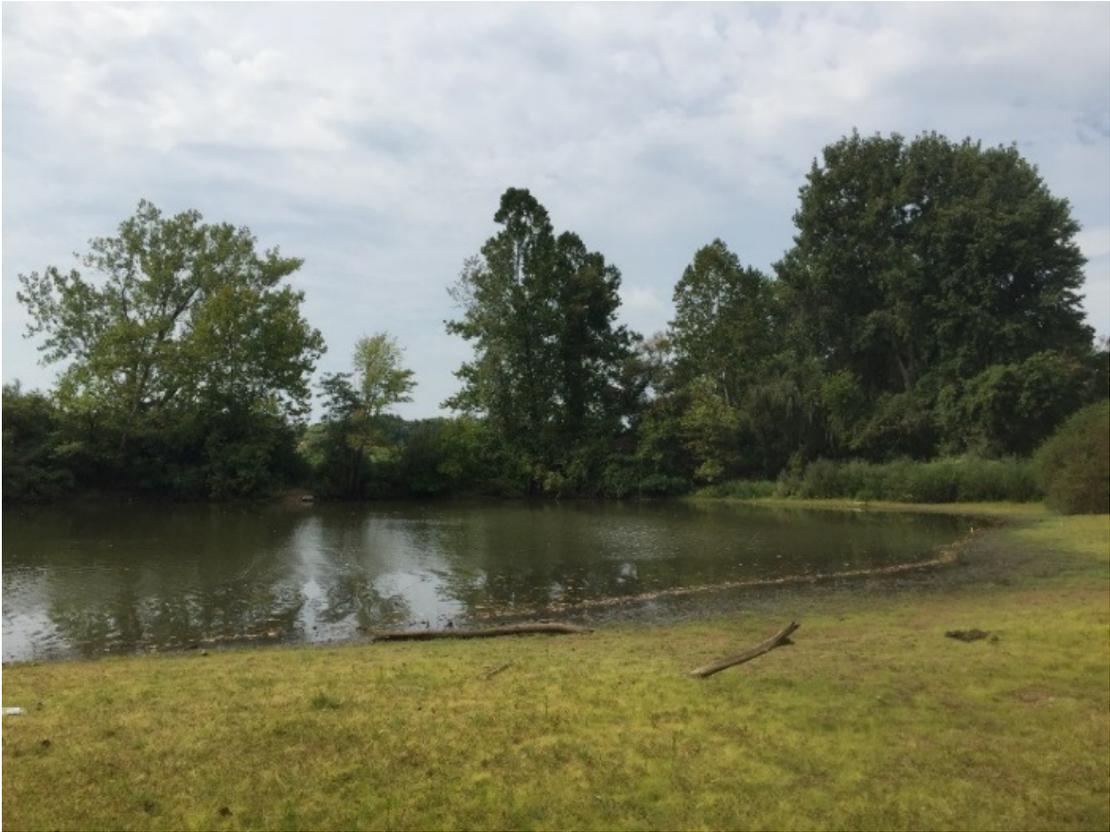
*Figure 20:* Remnant in-stream mining backwater with heavy silt deposits.

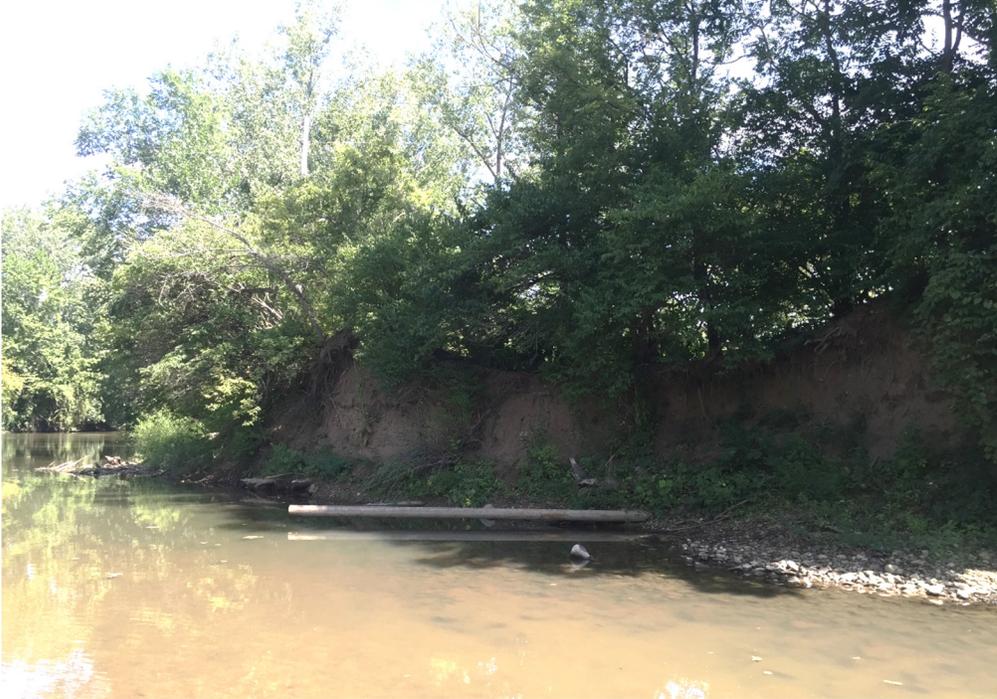
*Figure 21:* Severe bank erosion on the northwest corner of Quarry 3. The Mount Vernon Engineering Department reports that the abandoned pipe protruding above the water extended about 2 feet from the bank five years ago, but now extends much further due to erosion.

The right descending river bank remains tall and steep here, especially in the transitional area from the backwater to the narrowing channel next to Quarry 3 (at Norton Street). Extreme erosion is of particular concern here because it could lead to a levee breach. The left descending bank contains better riparian quality; although a levee does limit floodplain access, it is not found directly on the river banks.

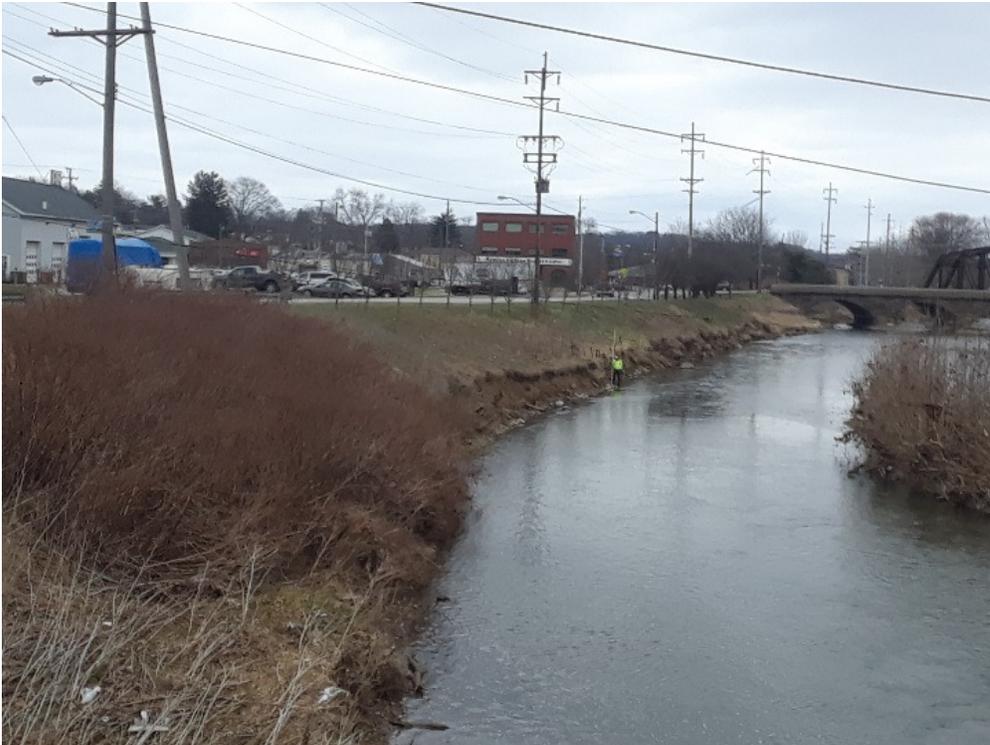
*Figure 22:* The left descending river bank adjacent to Phillips Drive and upstream of Main Street (visible in background) at RM 26.4-26.3 is eroding and unable to support riparian vegetation.

The 2010 Ohio EPA report noted a generally intact forested riparian corridor for the Kokosing River mainstem; the amount forested to at least 100 feet was 56.1% of the length of both banks. However, the authors described the riparian forests through Mount Vernon (from RM 25 to RM 29) as “minimal to nonexistent,” containing the least amount in the Kokosing watershed (p. 27). Figure 2 shows a relatively thin corridor that is nearly absent in a few locations. The northern (or left descending) river bank upstream of Main Street, for instance, is very steep, eroding and unable to maintain vegetation beyond grass and opportunistic weeds. Phillips Drive is located at the top of the slope, leaving space for only a few landscaping trees between the river and the streets of downtown Mount Vernon (Figure 22).

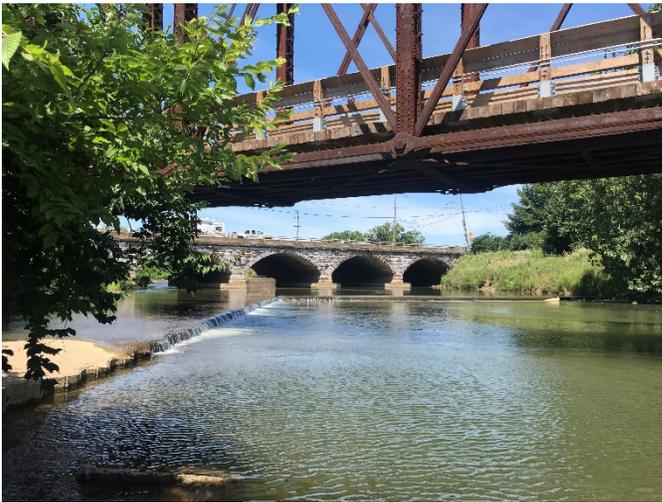
*Figure 23:* A sanitary sewer line crosses the Kokosing River just downstream of Main Street (and upstream of a multi-use trail bridge visible in the foreground) but is too small to impound a significant amount of water.

A sanitary sewer line crosses the Kokosing River immediately downstream of Main Street and before the terminus of the subwatershed. The line extends approximately nine inches above the normal water level of the river and impounds very little water; a shallow riffle less than 200 feet upstream is visible in the photo below. According the Mount Vernon Engineering Department, the sewer line has been rehabilitated in the last five years (B. Ball, personal communication, May, 15, 2018).
