# SPOT THE DIFFERENCE: Kokosing River Restoration Project

## WHAT WILL THE DIFFERENCES BE IN THE FUTURE: Kokosing River Restoration Project

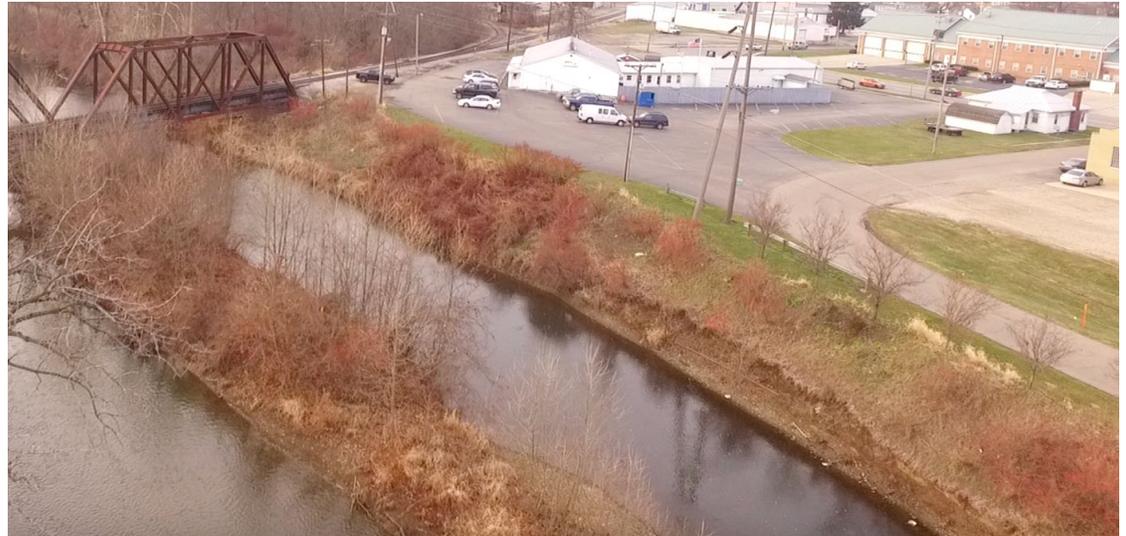
**Photo 1**

1. The erosion on the right side of the river bank was repaired through re-grading these areas.
2. Non-native vegetation in photo 1 on the right side of the river bank was cleared and new river bank protection and native riparian vegetation was added such as:

**BEFORE Phase 3**  
**of restoration**  
**started**

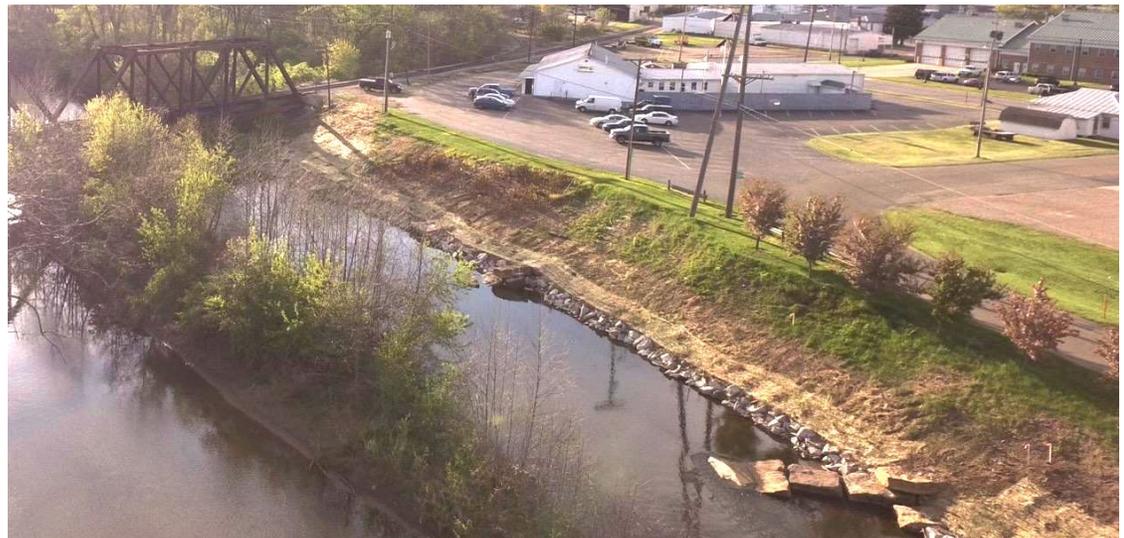
**Photo 2**

3. The angled blocks of sandstone boulders, known as cross vanes, seen in photo 2, has redirected the river flow back towards the center of this channel to reduce river bank erosion and allow for a stable riparian corridor.

**One month**  
**AFTER Phase 3**  
**of restoration**  
**completed**

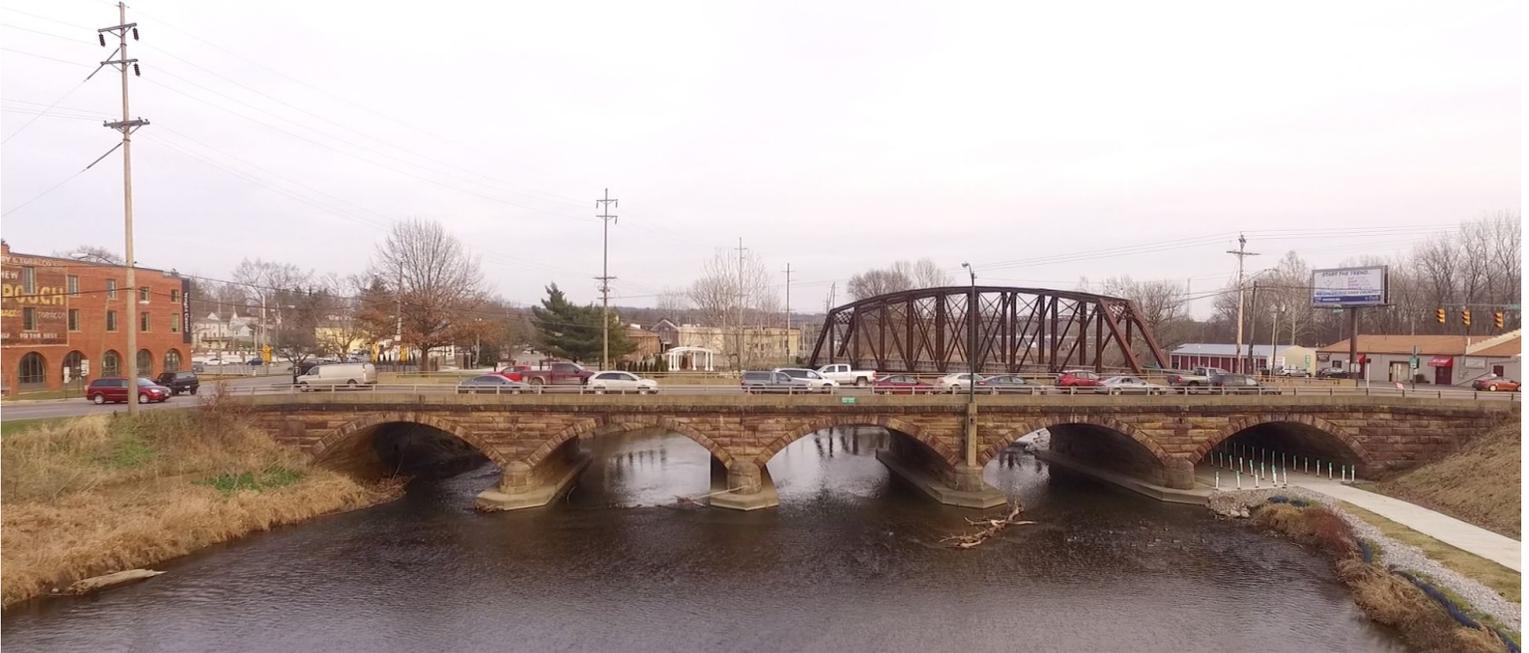
***This is an overhead shot of what SR 13 currently looks like. With the future relocation, traffic is going to improve and there will be a decrease stormwater discharge entering our Scenic Kokosing River so it can continue to flourish for the local aquatic habitats it supports.***

This project will create a larger, more sustainable, riparian corridor and will allow room for additional stormwater management facilities which will protect the river from discharge. There is currently large amounts of direct stormwater discharge going into the river which is caused from the heavy use of the current SR 13 area and other connected roadways which can be dangerous to the habitats in the river.
